# Using Ultraviolet-Induced Fluorescence to Enhance an LNAPL Conceptual Site Model

Bobbilynne Koepke, RG & Daniel Yoakum  
Environmental Works, Inc.  
MWCC Environmental Conference 2018

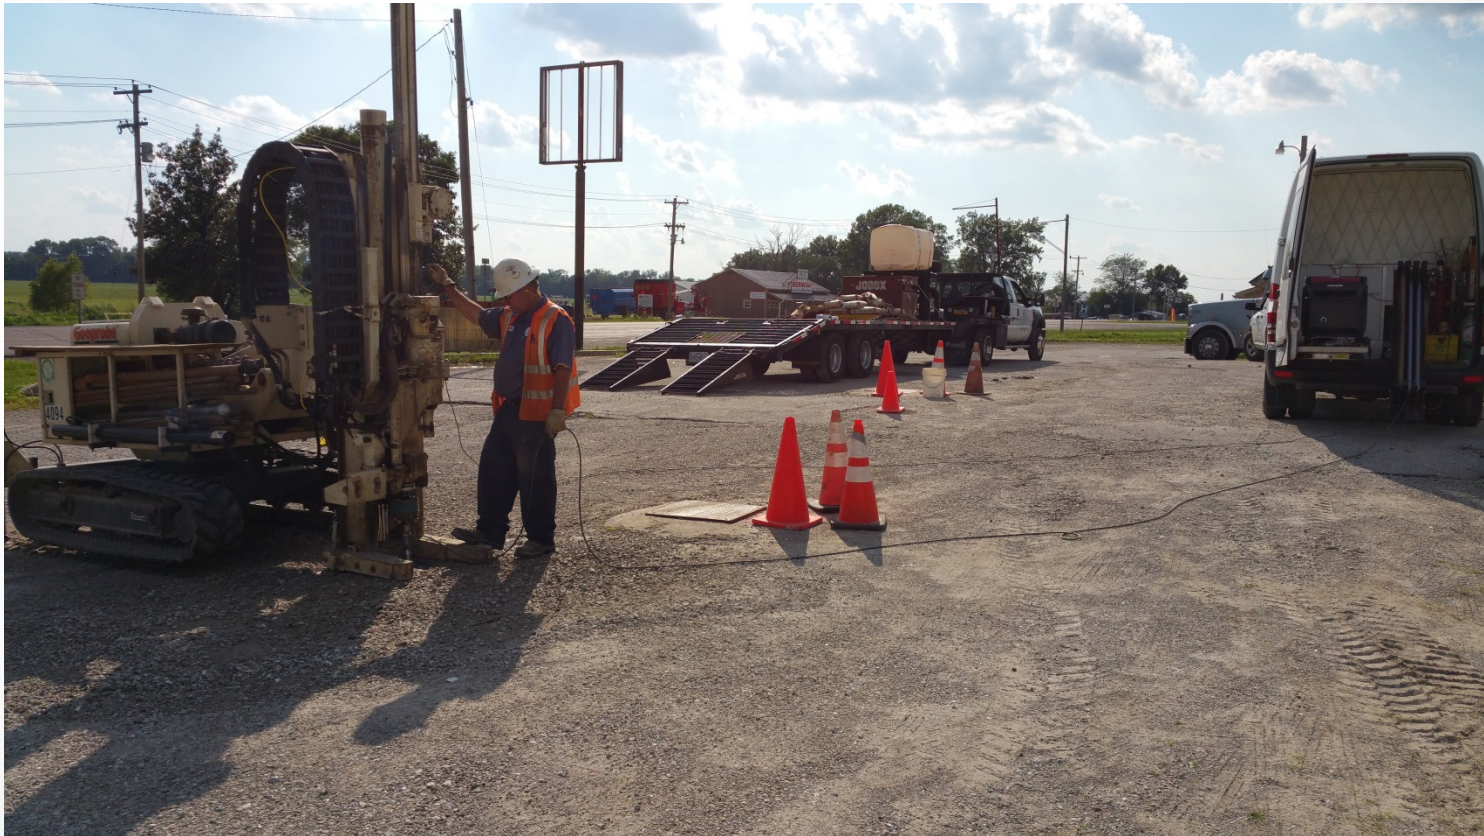
- DPT tooling

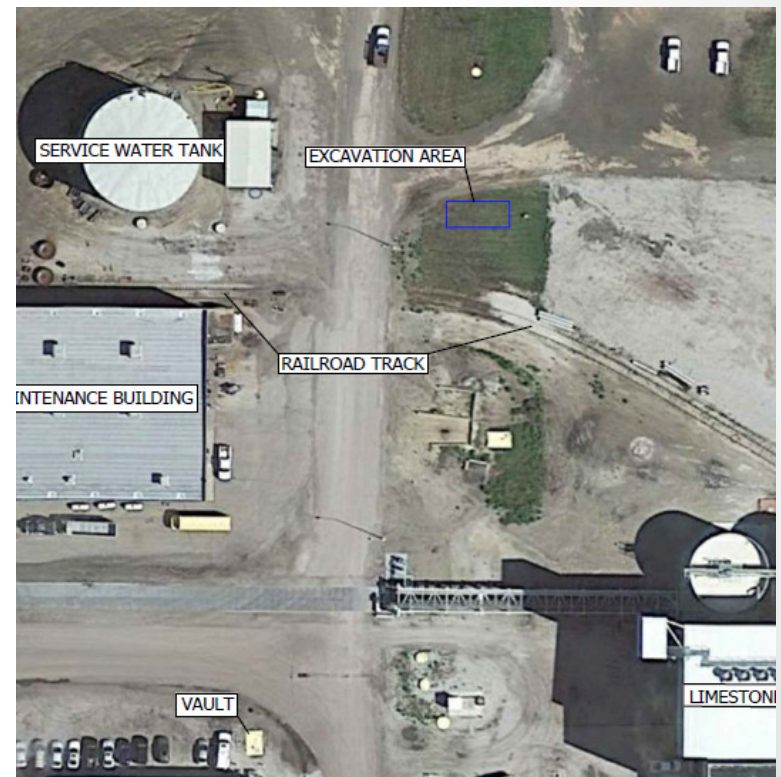
- Power Plant near Kansas City
- Fuel discovered in onsite pond – old French drain 25 ft bgs
- Limited excavation, line cleaning, and camera could not identify source
- Large volume of underground pipelines and utilities

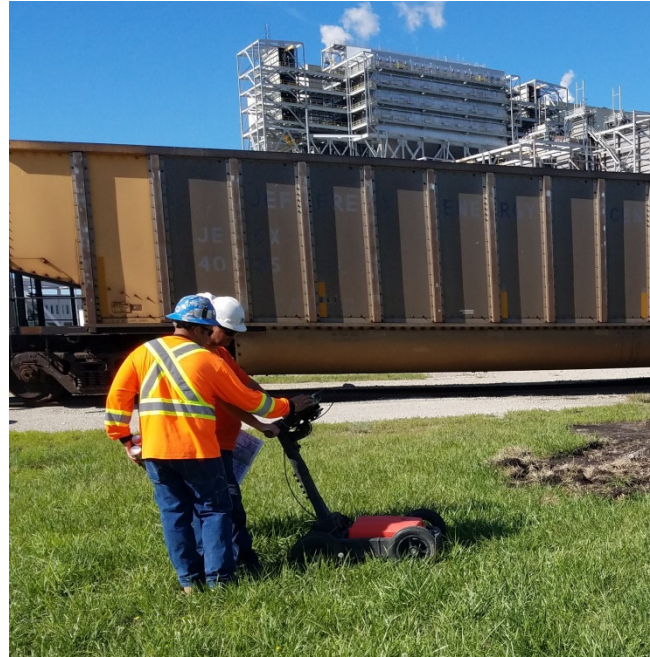
- EWI used in-house GPR with Line Trac to locate product lines and depths
- Advanced OIP along the possible leaking lines

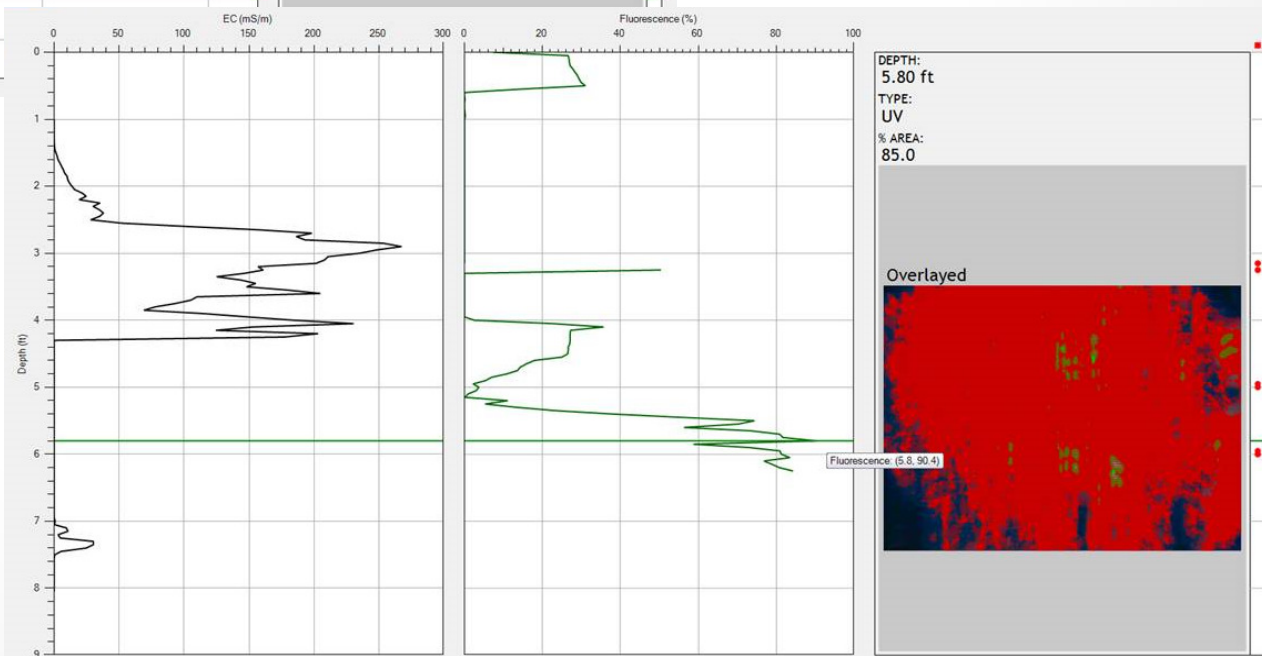
## Separate borings

- Top left shows optical when fill around product line was encountered (no LNAPL)
- Bottom shows UV fluorescence in fill material at 5.8 ft bgs

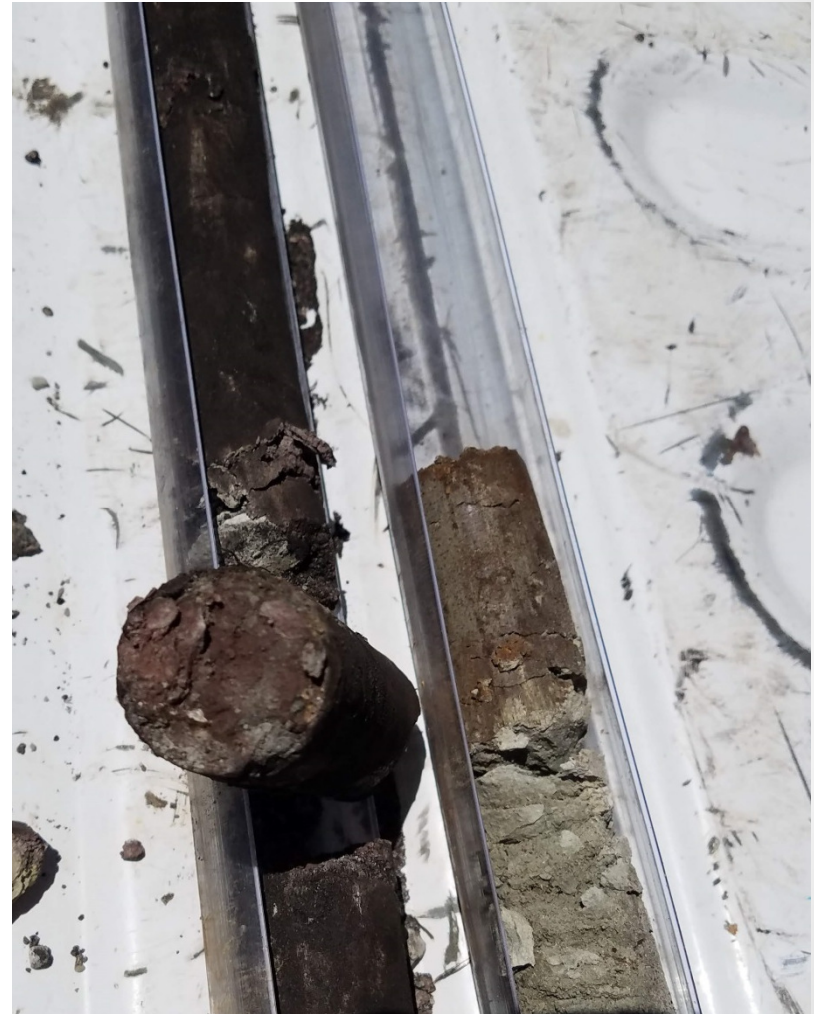
- EWI was able to find general source area in 1 day
- Borings advanced adjacent to OIP boreholes to collect soil samples and confirm results
- OIP borings also ID'd diesel fuel in the soils along a water line corridor
